Appendix A-1 – New York

Damaged, unsecured, and broken poles

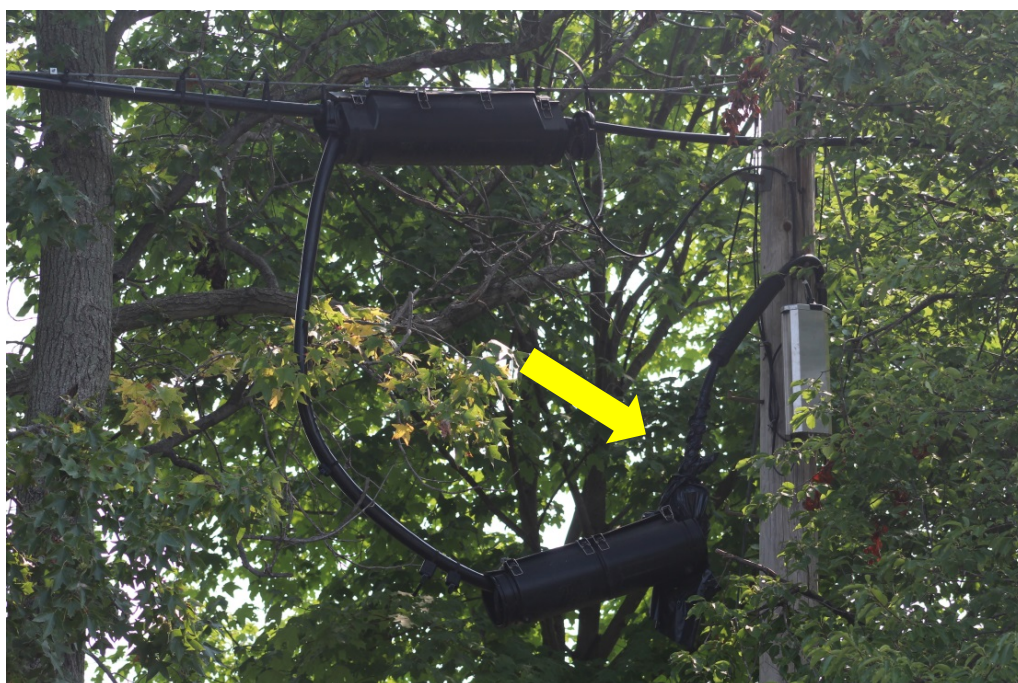
12. The picture below from Pole 16 Dominion Road, Chester in Queen Anne's County, MD (north of Ocean City) shows multiple service affecting problems. First there is a splice terminal that should be secured to the strand. The end collar or stub is pulled out of the splice case. It is upside-down and the temporary, black plastic wrapping (yellow arrow) on the right side allows it collect water. Water deteriorates the wires and affects service.

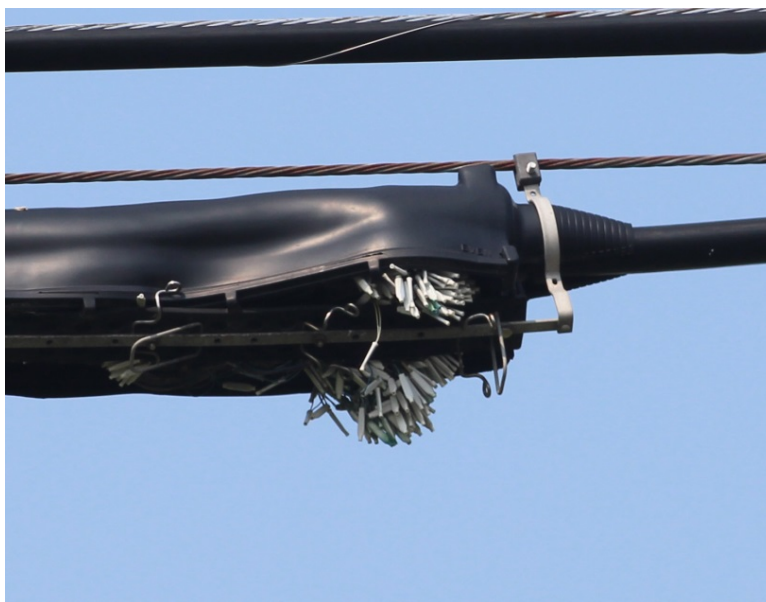
13. The picture below from Pole 31 on Cox Neck Road, Chester, in Queen Anne's County, MD (north of Ocean City) is a closure from the 1980's before the Company replaced these soft closures with hard plastic cases. It shows wires exposed to the elements. Exposed wires will short out customer phone lines. Water, insects, and animals get into the closure, damaging wires and affecting service.

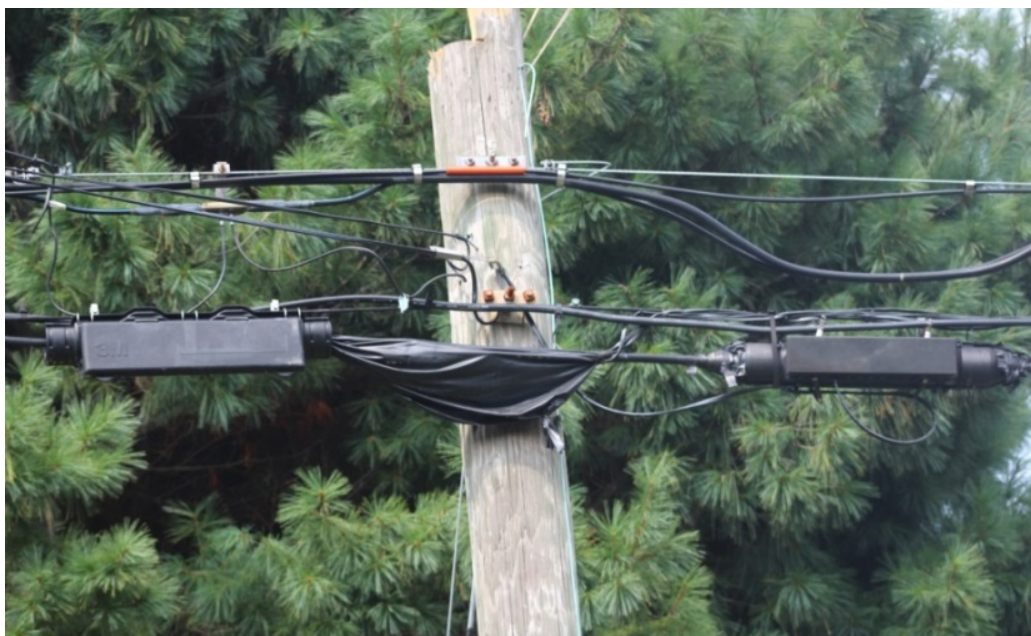
14. The picture below from Pole 2, North Lake Drive, Stevensville in Queen Anne's County, MD shows plastic wrapped around the cable between two splice terminals which each house 100-200 customers lines. Water runs into the plastic and forms the "belly" that pulls on the wrapping. The covering collects water, deteriorating the wires and affecting service.

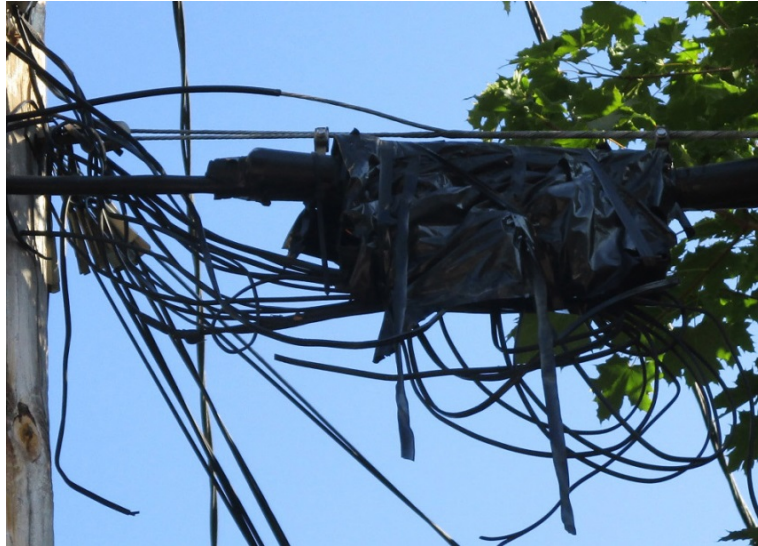
15. The picture below from 1700 Ingram Road, Baltimore in Baltimore County, MD shows a splice case with deteriorated black plastic covering. Deteriorated covering leaves wires susceptible to damage from weather and animals. Damaged wires cause repeated customer service outages.

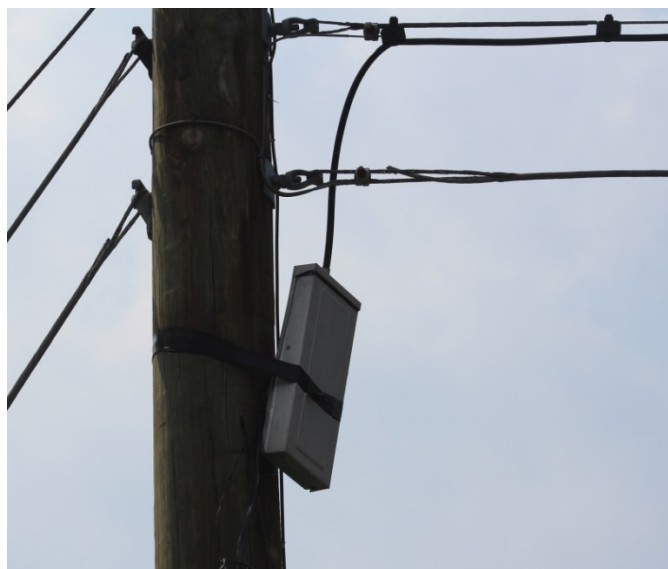
16. The picture below of Pole 10 on Elm Street, Stevensville in Queen Anne's County, MD shows a terminal taped shut and taped to a pole. The terminal should be secured to the pole. Likely this pole had been replaced and contractors taped the box to the pole instead of properly reattaching it and the wires below the box. Working on the terminal would require cutting the tape, which would cause the sharp-edged case front to fall outward on the technician. This is both a worker safety concern and service quality affecting because the tape will eventually deteriorate and allow the terminal to swing loose on the pole or swing open.

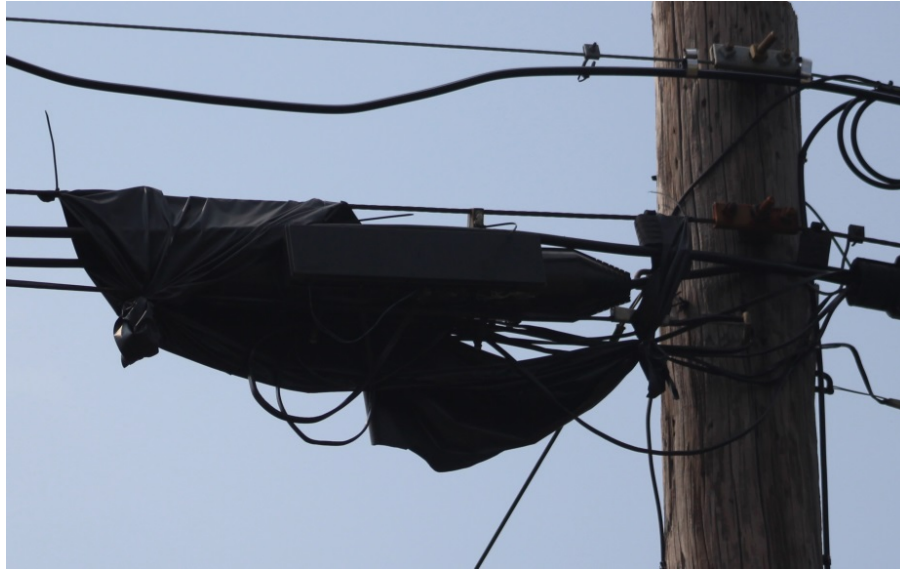
17. The picture below from Ped 2, Beach Drive, Stevensville in Queen Anne's County, MD shows a splice terminal that has been wrapped with a temporary plastic covering. There are exposed wires underneath the covering. The covering collects water, deteriorating the wires and affecting service.

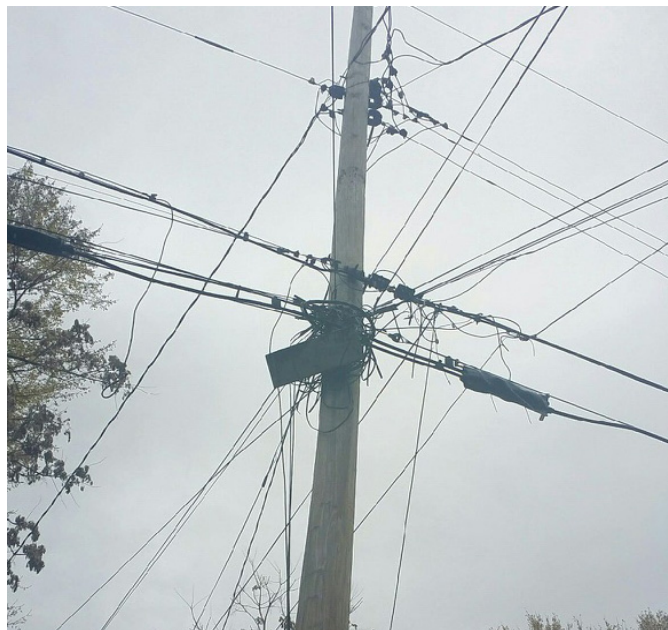
18. The picture below from 1105 Elbank Avenue, Baltimore City, MD shows a terminal that is not attached to the pole. It appears to be wrapped and tied to the pole with wires and cable ties. The terminal should be vertical and secured to the pole. Working on the terminal would require untying the wire and cutting the cable ties which would cause the terminal to flip and potentially hit the technician. This is a worker safety concern because the wire will deteriorate and the terminal will swing or open.

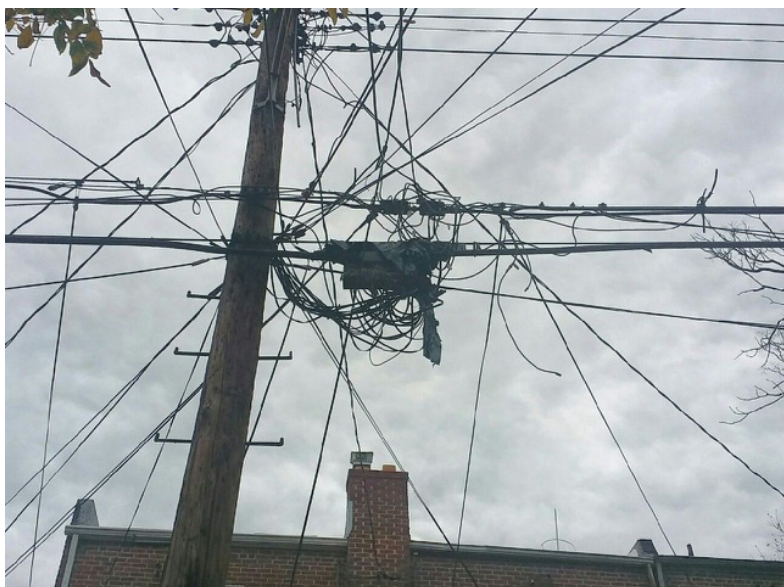
19. The picture below from 732 Glenwood Avenue, Baltimore City, MD shows a terminal with deteriorated black plastic covering. Deteriorated covering leaves wires susceptible to damage from weather and animals. It can also create an unsafe environment by allowing bees to nest in the wires. Damaged wires that are exposed to the elements are more likely to affect service.

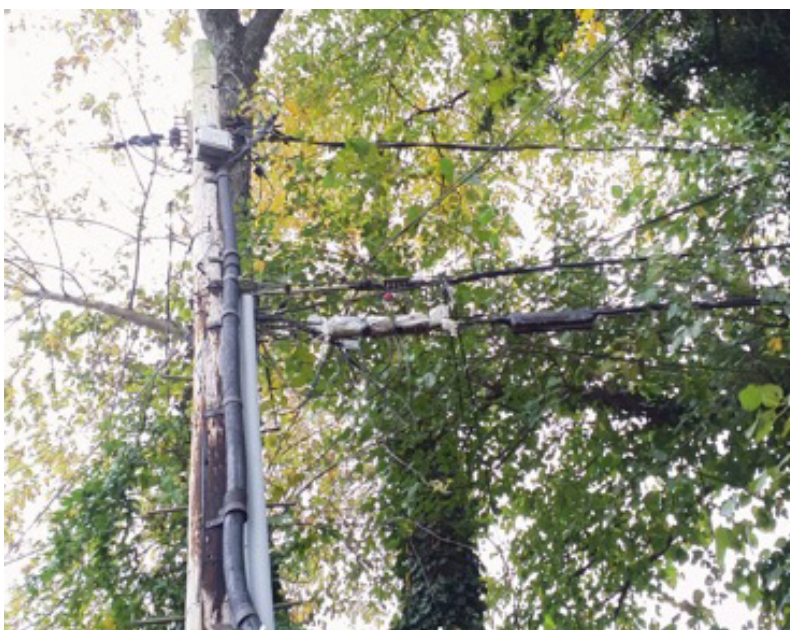
20. The picture below from Baltimore City, MD shows a white plastic wrap over a defective cable. The clear plastic is the shipping material the SLIC enclosure comes in. This is an example of a technician not having the proper material available to them. There are exposed wires underneath the covering. The covering collects water, which deteriorates the wires and affects service.

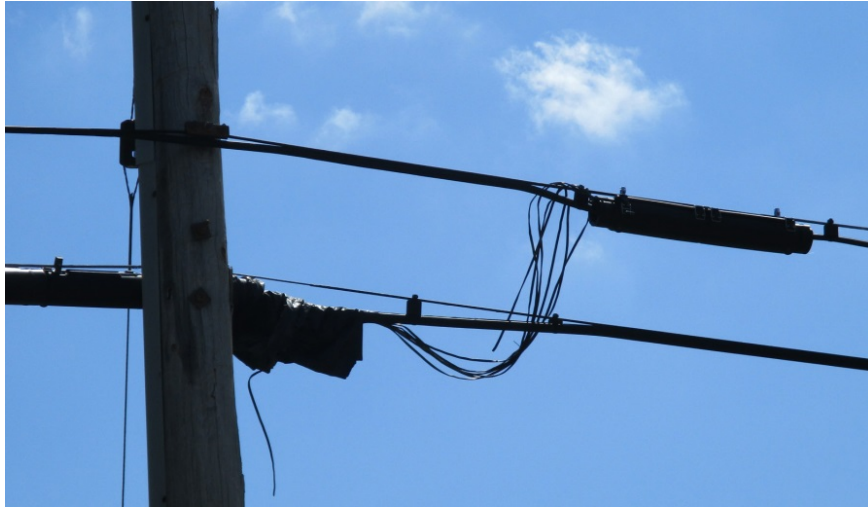
21. The picture below from 13001 Long Green Pike, Manor in Baltimore County, MD shows a black plastic wrap covering a defective cable and multiple wires bypassing a defective 200-pair cable. The cable is bypassed using drop wires, which are not meant for outdoor use. They will deteriorate faster than the cable. As they deteriorate, there will be service issues.

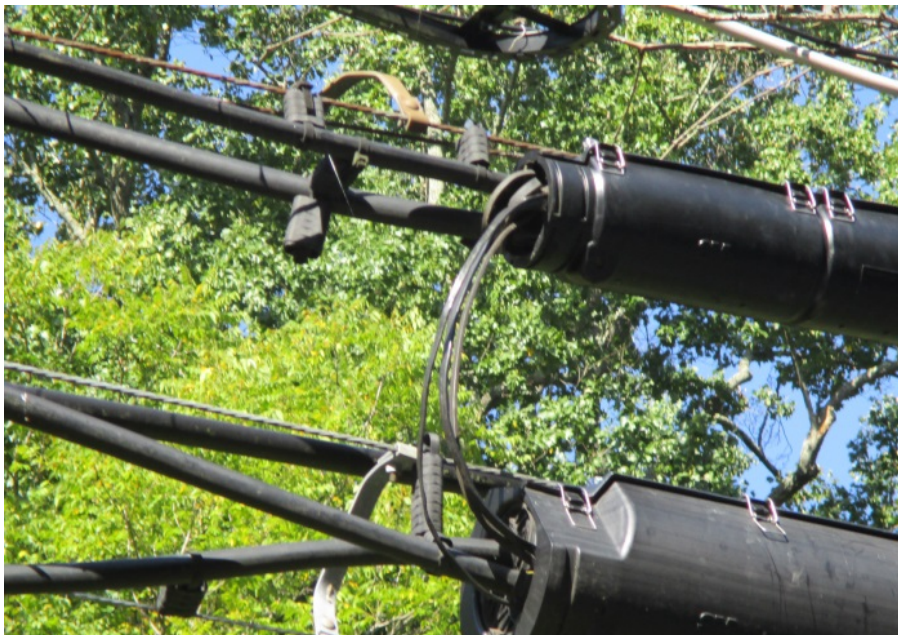
22. The picture below from Pole 53 Wiseburg Road, Parkton in Baltimore County, MD shows multiple wires bypassing a defective cable. The cable is bypassed using drop wires, which are not meant for outdoor use. They will deteriorate faster than the cable. As they deteriorate, there will be service issues.

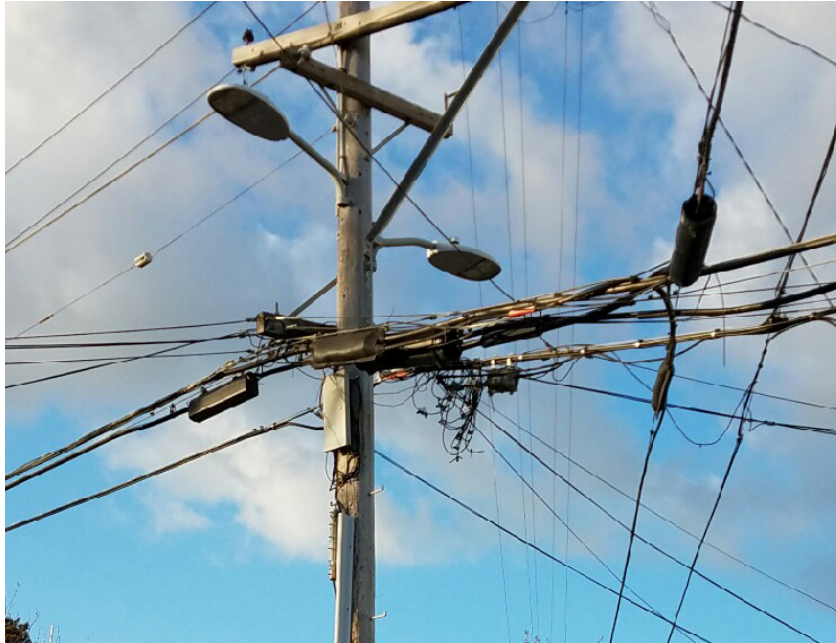
1. This picture below shows a damaged splice case with exposed service wires. Exposed wires are susceptible to damage from weather and animals, leading to repeated customer service outages.

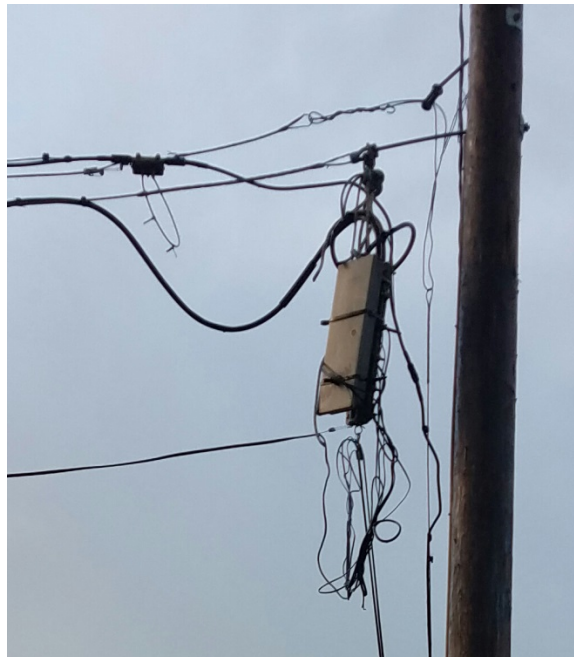
2. This picture below shows a hanging terminal unattached to a utility pole. The terminal should be secured to the pole. The wire will deteriorate and the terminal will fall, leading to service and safety issues.

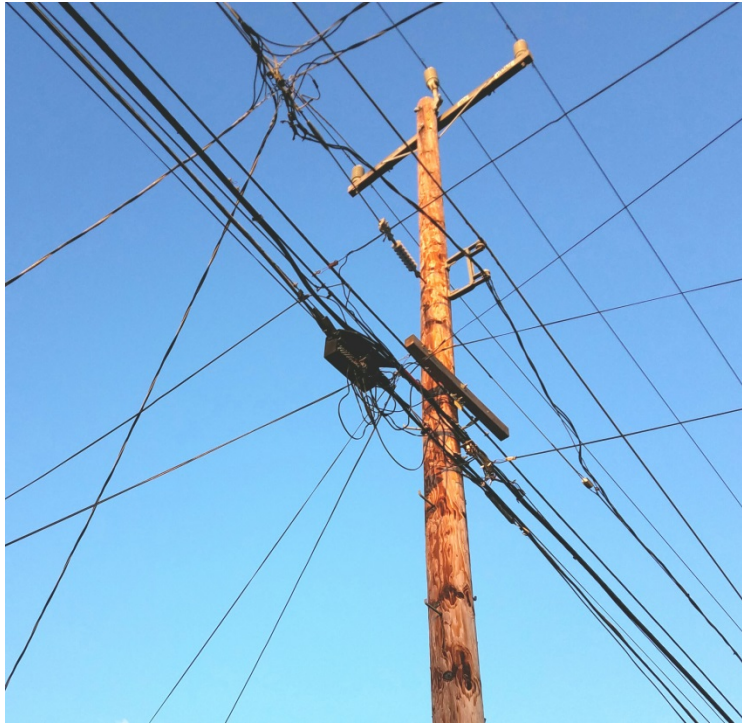
3. This picture below shows an open splice box with exposed service wires. These service wires are exposed to the elements and animals, which will deteriorate the wires and lead to service issues.

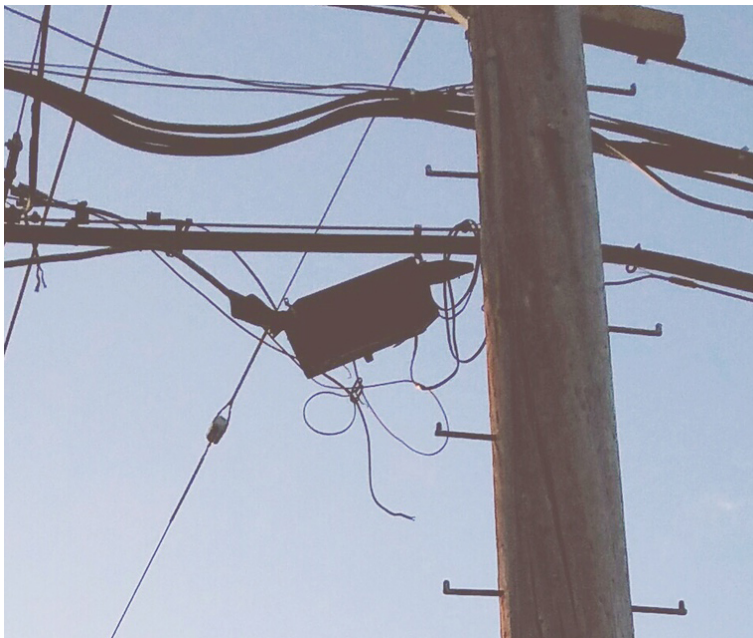
4. This picture below shows a dangling splice box. The Box should be attached to the cable. Without being secured to the cable, the box is not secure. The elements and animals can enter the box and deteriorate the wires. This can lead to service and worker safety issues.

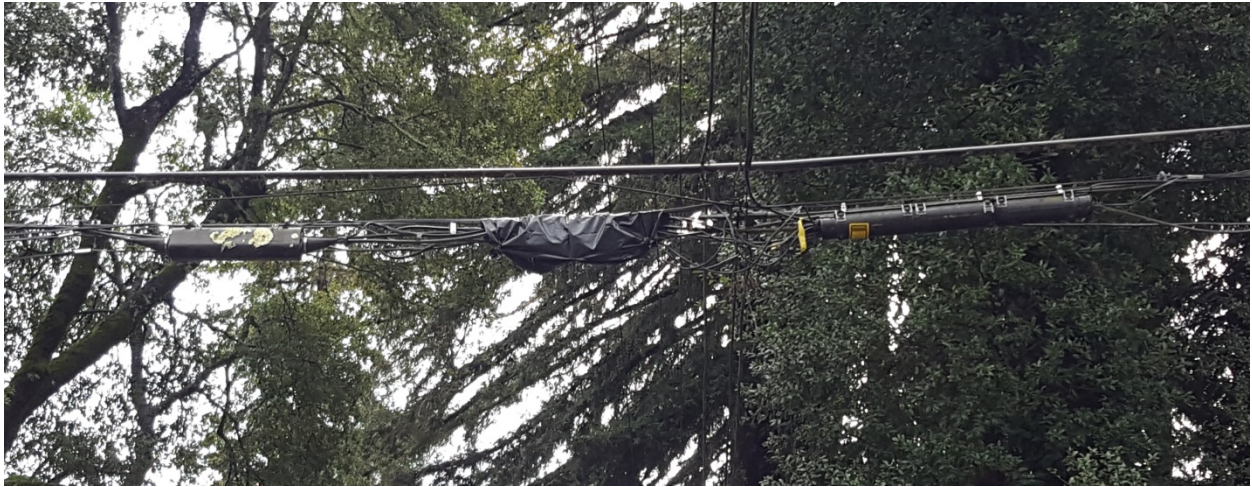
5. This picture below shows multiple issues. First, it shows a splice terminal that has been wrapped with a temporary plastic covering. There are exposed wires underneath the covering. The covering collects water, deteriorating the wires and affecting service. Second, the cable itself is badly damaged. It is so damaged there are at least four splice boxes on a single span of a few feet. Each splice box covers a portion of damaged or defective cable. Each of the numerous thin wires would have been installed in response to a separate customer complaint.
